Pre-Purchase Survey

Place of Survey: Lefkas Marina, Lefkas, Greece

Vessel Type: Sailing Yacht

Builder: Hanse

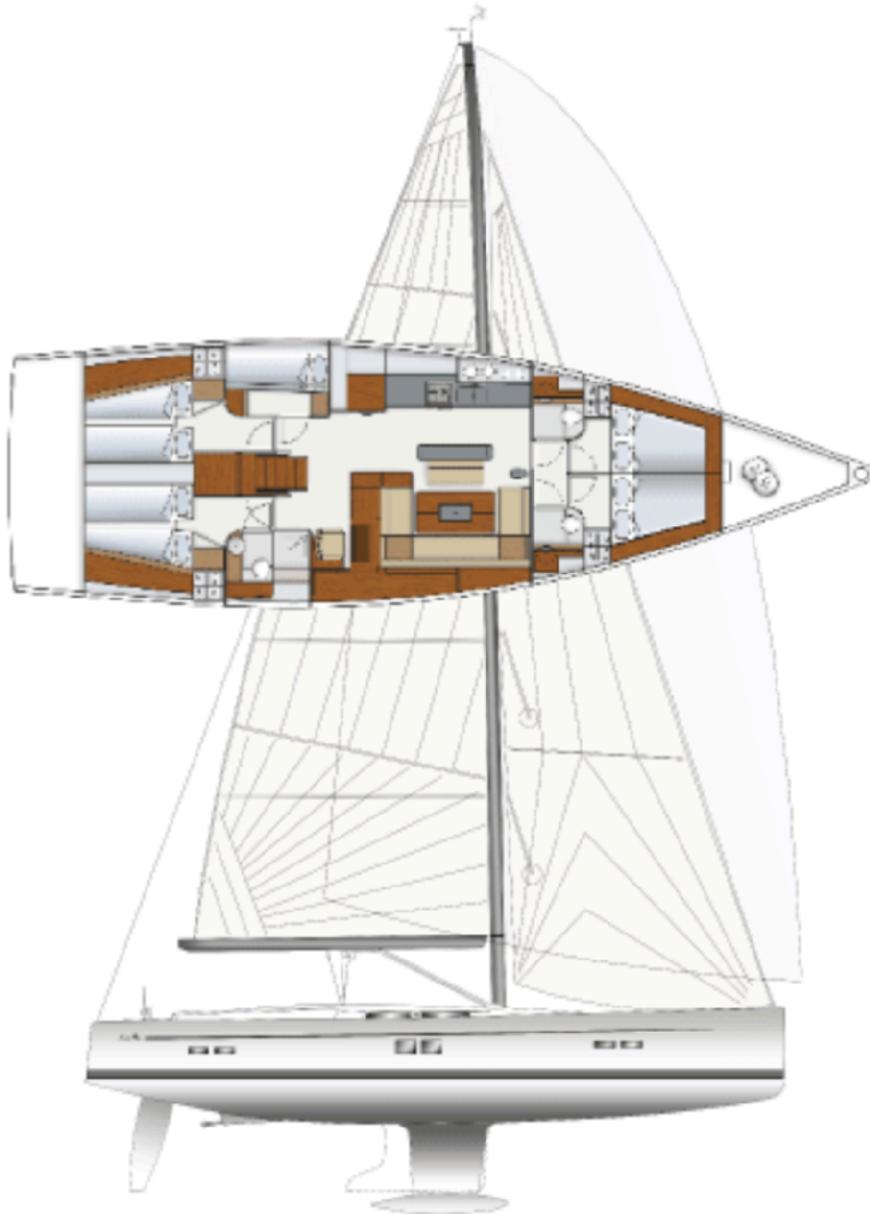
3. Keel

The vessel had a shoal draft cast iron keel. The keel had been coated with the same anti fouling as the rest of the underwater hull which was in good serviceable condition.

- The keel was through bolted into place. Eight 40mm, and two 30mm keel bolts which were located and inspected in the bilge. These were found beneath sole boards within the saloon.
