Pre-Purchase Survey

Place of Survey: Cleopatra Marina, Aktio, Greece

Vessel Type: Sailing Yacht

Builder: Najad

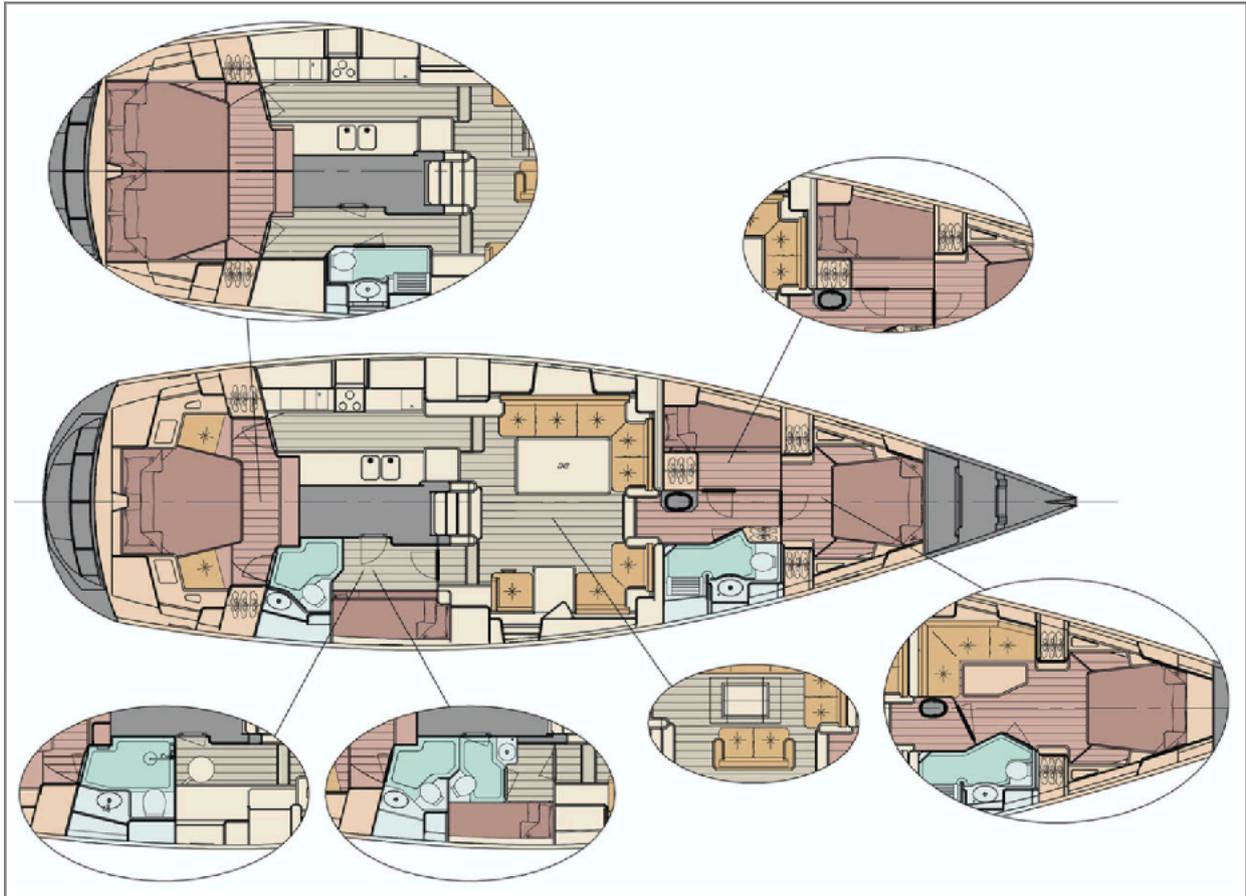
'— — — — —' was reported as being built in 2007 by Najad Yachts. The vessel which was a successful production vessel of the cruising class was built in Sweden. She was a centre cockpit, displacement cruising yacht with a L-shaped shoal draft cast iron keel. The vessel had a sloop rig with powder coated alloy mast and boom. The auxiliary engine was a Volvo Penta diesel, with shaft and single propeller. The hull was of moulded GRP finished in white gel coat and flag blue awlgrip top coat.
