Pre-Purchase Survey

Vessel name: Breezer

Vessel Type: Sailing Yacht

Builder: Sweden Yachts

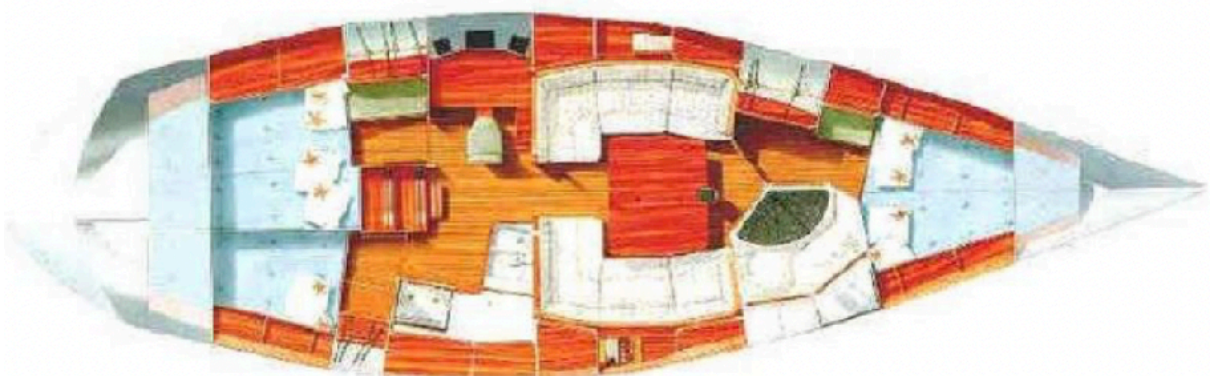
'————' was reported as being built in 2000 by Sweden Yachts. The vessel which was a successful production vessel of the cruising class was built in Sweden. She was an aft cockpit, displacement cruising yacht with a lead keel. The vessel had a sloop rig with alloy mast and boom. The auxiliary engine was a Volvo diesel, with sail drive and single propeller. The hull was of moulded GRP finished in off white gel coat.
